No. 943

TESTS OF LEAD-BRONZE BEARINGS IN THE DVL BEARING-TESTING MACHINE

By G. Fischer

TECHNICAL MEMORANDUM NO. 943

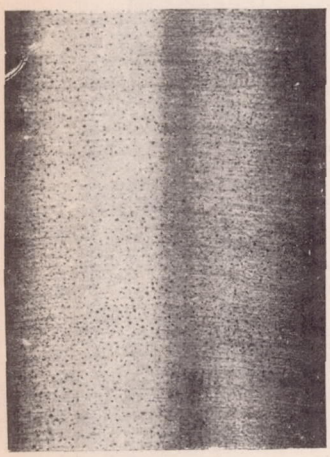
Figure 18.- Alloy 30 IV. Showing multitude of small lead inclusions after finishing operation.Magnification 2X.

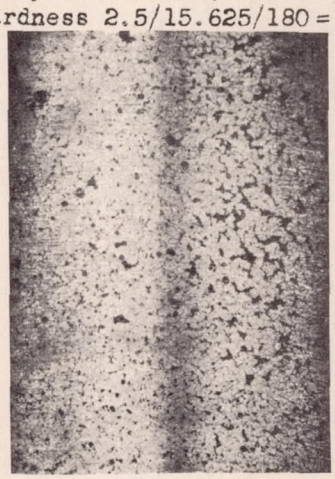
Figure 19.- Alloy 40 II. Showing numerous large lead inclusions after finishing operation.Magnification 2X.

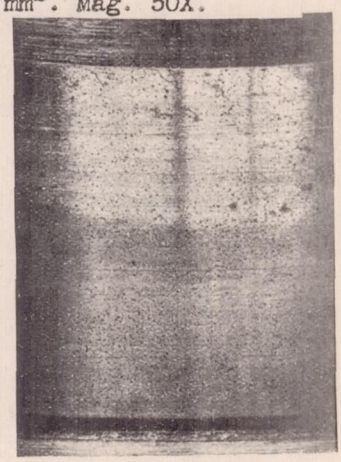
Figure 20.- Alloy 30 I (test bearing 932). Condition after test under static load up to 70kg/cm^2 side pressure, showing numerous small pores(instead of lead inclusion before the test). Notice on loaded side(near top of figure) small fracture and crack. Magnification 2X.

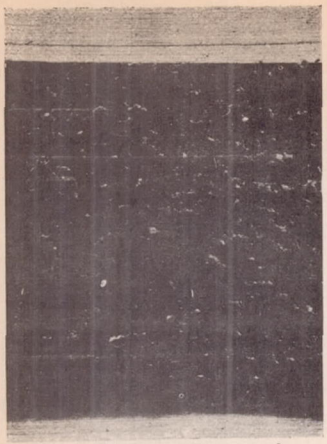
Fig.21.- Alloy 40 II (test bearing 342).State after 51 hr run under dynamic load with p=250(210) Kg/cm^2, showing medium and large pores (instead of lead inclusions before test). Also showing beginning of scoring. Magnification 2X.

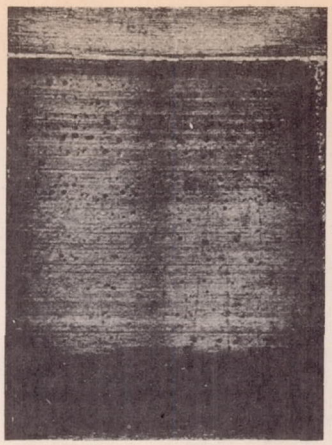
Fig.22.- Alloy 30 V (test bearing 531). State after test run under static load up to p=135 Kg/cm^2, showing numerous large pores (already present before test) and light scoring. Mag. 2X.

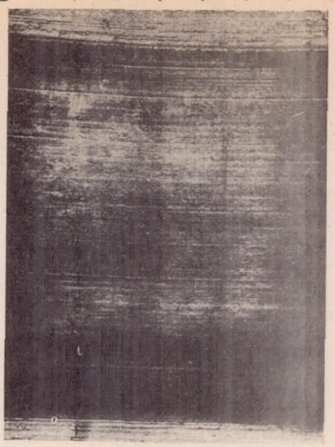
Fig.23.- Alloy 40 I (test bearing 942).State of bearing after test run under dynamic load up to p=550 Kg/cm^2, showing light and some heavier scoring. Magnification 2X.

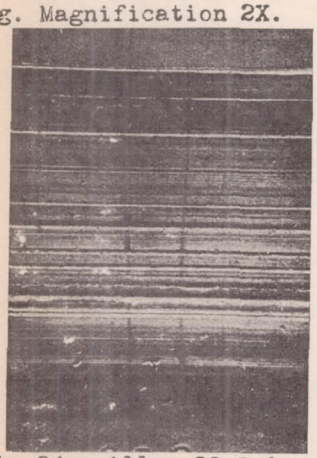
Fig.24.- Alloy 20 I (test bearing 922). State after 97 hr of testing under static load of p=250(190) Kg/cm^2. Test run showing a few light and six heavy scorings,also a few scars. (lines across center are caused by measuring tool). Magnification 2X.

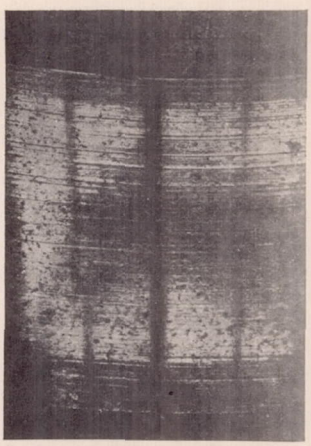
Fig.26.- Alloy 20 III(test bearing 1231). State of the unloaded zone after dry run under dynamic load with p=250 Kg/cm^2, showing numerous fractures and scars,also a few light and heavy scorings. Magnification 2X.

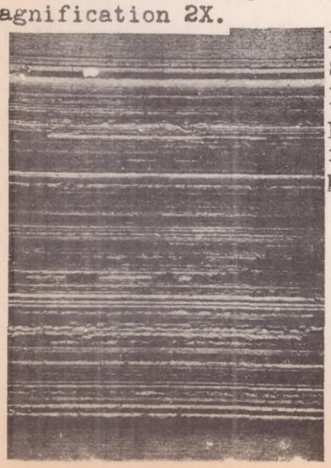
Fig.27.- Alloy 30 IV(test bearing 831). State after test under static load with p=300 Kg/cm^2, showing complete destruction of bearing surface by heavy scoring and scouring. Magnification 2X.

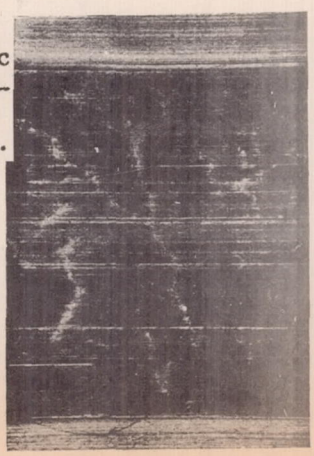
Fig.28.- Alloy 30 I (test bearing 937). State after 13 hours test under dynamic load with p=250(230) Kg/cm^2, showing numerous net-like cracks,also numerous pores and light scorings.Magnification 2X.

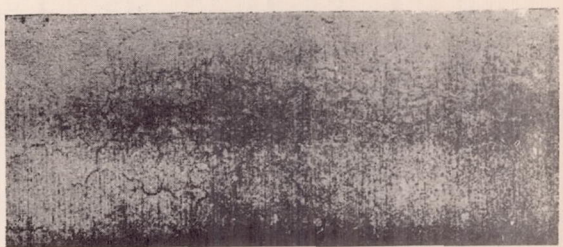
Figure 34.- Alloy 20 I.

Figures 34,35.- Crack forming of a finished bearing surface after two months storage. Magnification 2X.

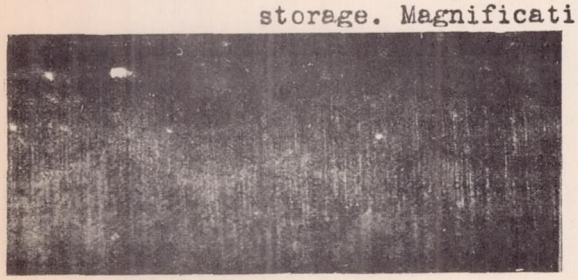
Figure 36.- Alloy 20 I.

Figures 36,37.- Crack forming of a finished bearing surface after heating to 160° C . Magnification 7.5X.

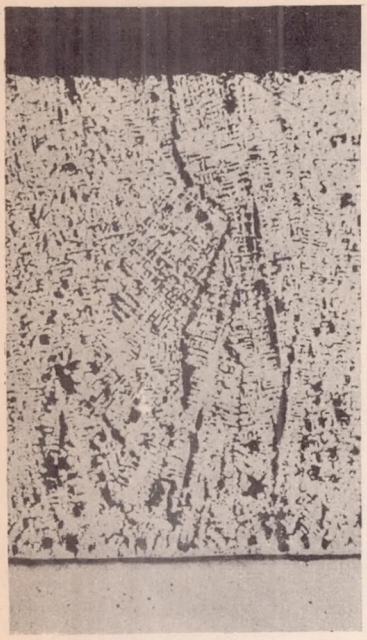
Figure 38.

Figures 38,39.- Cracks within the alloys illustrated in figures 34 and 35 made of alloys 20 I and 30 I. Magnification 50X.

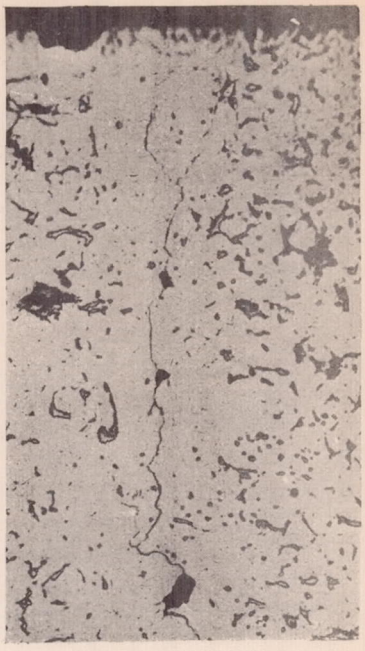
Figure 40.- Crack within the tested bearing material made of alloy 30 I (bearing 933). Magnification 200X.

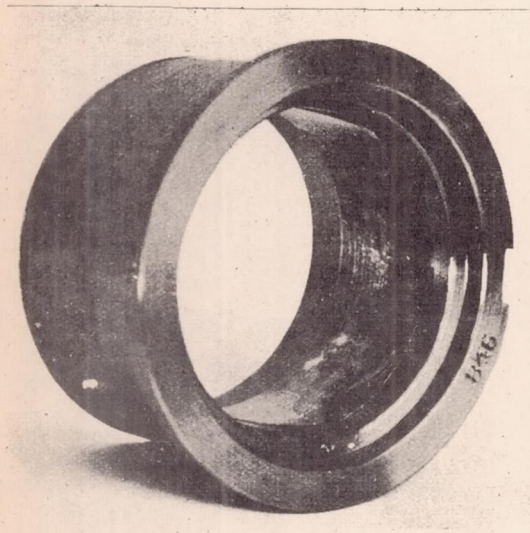
Figure 41.- Cracked surface of bearing 846, made of alloy 40 IV (42% Pb,28% Fe). State after 68 hours of dynamic test at $p = 250 Kg/cm^2$.

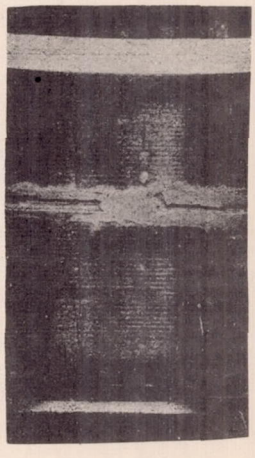
Figure 42.- Local lead collection in the running surface created by a foreign body during an endurance run. (The foreign part is visible next to the damaged part of the surface.)
